PHASE 2 GROUND INVESTIGATION

Lidl Great Britain Ltd
675 Gorseinon Rd, Gorseinon

Client: Lidl Great Britain Ltd

795.01.01
November 2020

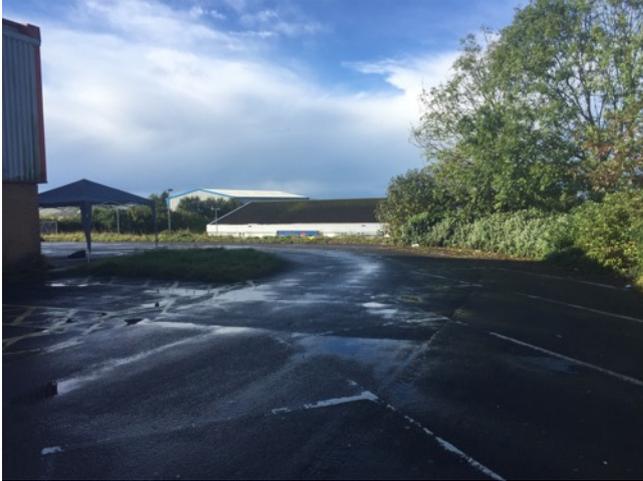
Photo 1: View westwards from the northern boundary of the site, with the existing Lidl retail store beyond, located approximately 4m lower than the Poundstretcher store

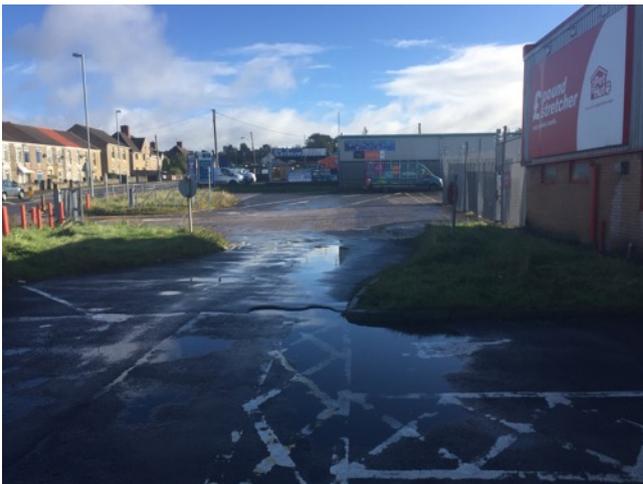
Photo 2: View eastwards along the northern frontage of the existing Poundstretcher store. The standing water on the car park followed a prolonged period of heavy rainfall overnight.

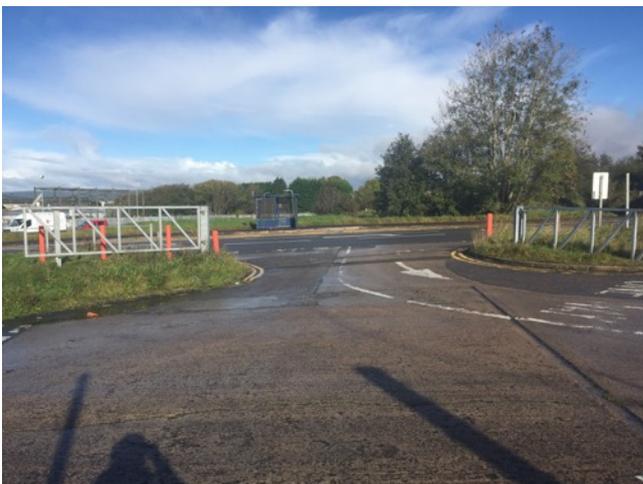
Photo 3: View northwards showing the present entrance onto Gorseinon Road.

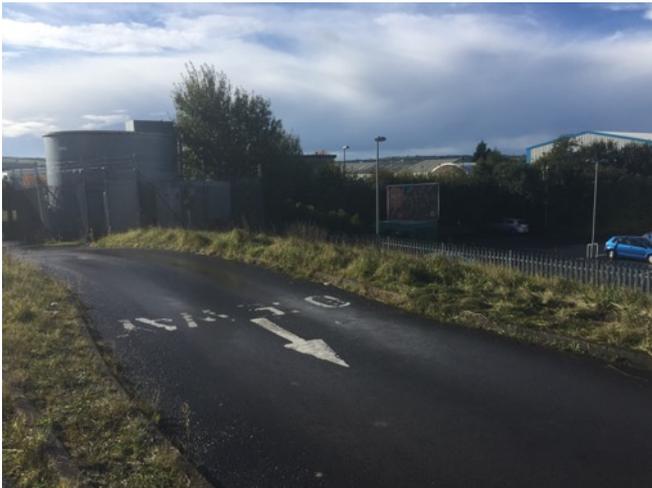
Photo 4: View towards the south-west along the western boundary of the site. The large on-site tank in the distance is a water-storage tank for the Poundstretcher store's sprinkler system.

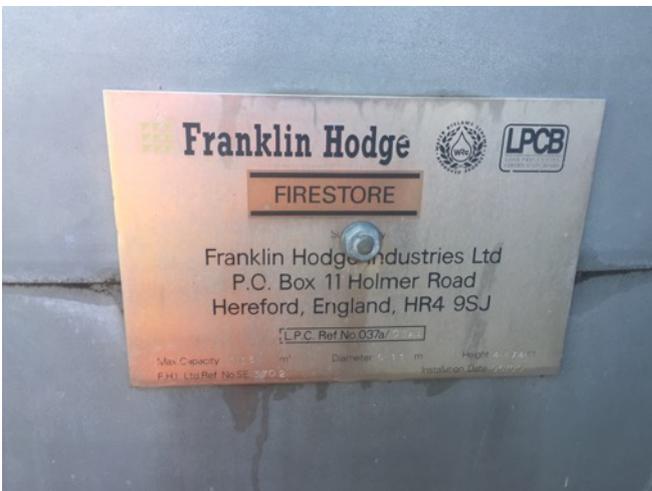
Photo 5: Detail of the maker's plate on the water storage tank.

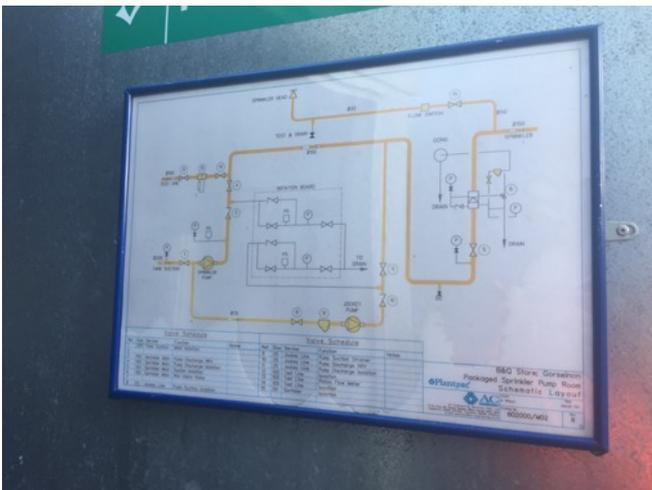
Photo 6: Detail of the sprinkler system's schematic layout drawing on display adjacent to the tank. The drawing pre-dates Poundstretcher's operations at the site and is labelled as serving the previous B&Q builders' merchants store on the site.

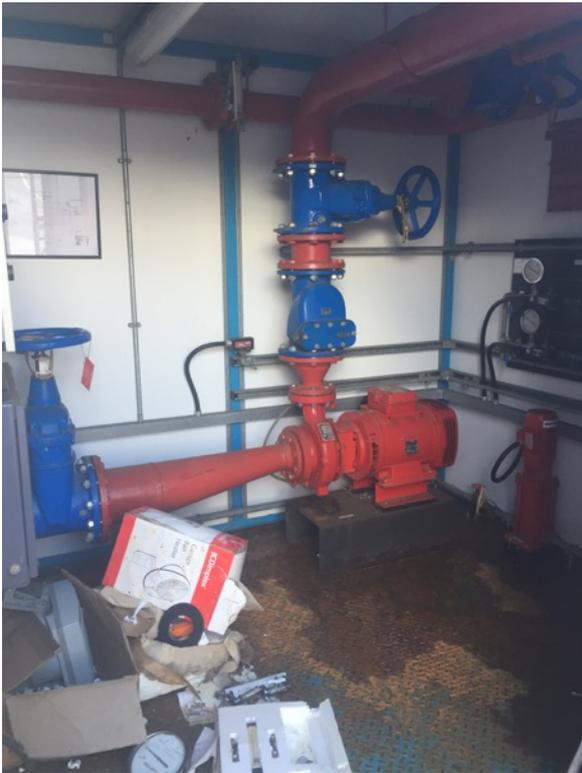
Photo 7: View inside the sprinkler pump room adjacent to the above ground tank in the south-western corner of the site.

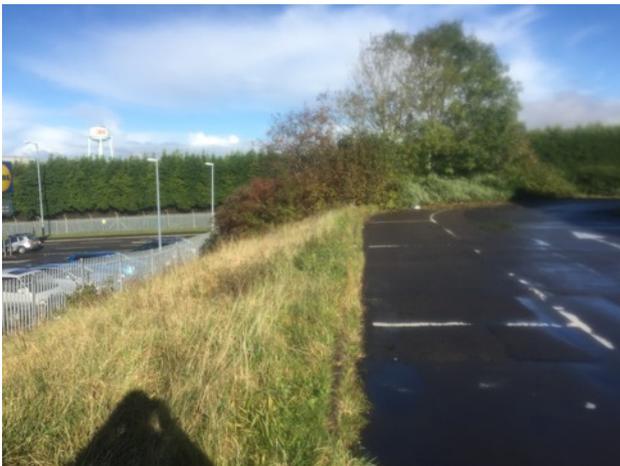
Photo 8: Along the western boundary looking northwards, showing the steep embankment down from the Poundstretcher car park to the adjacent Lidl store car park. The site boundary is marked by the metal palisade fencing.

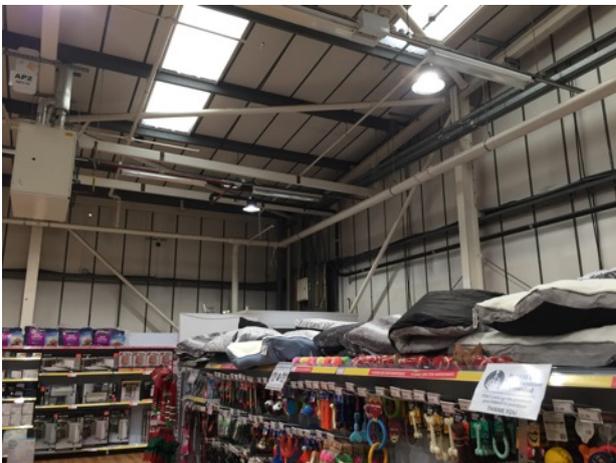
Photo 9: Interior view of the north-western corner of the existing Poundstretcher retail store, showing the steel-framed construction.

Foundations associated with the existing structure will need to be removed prior to redevelopment of the site.

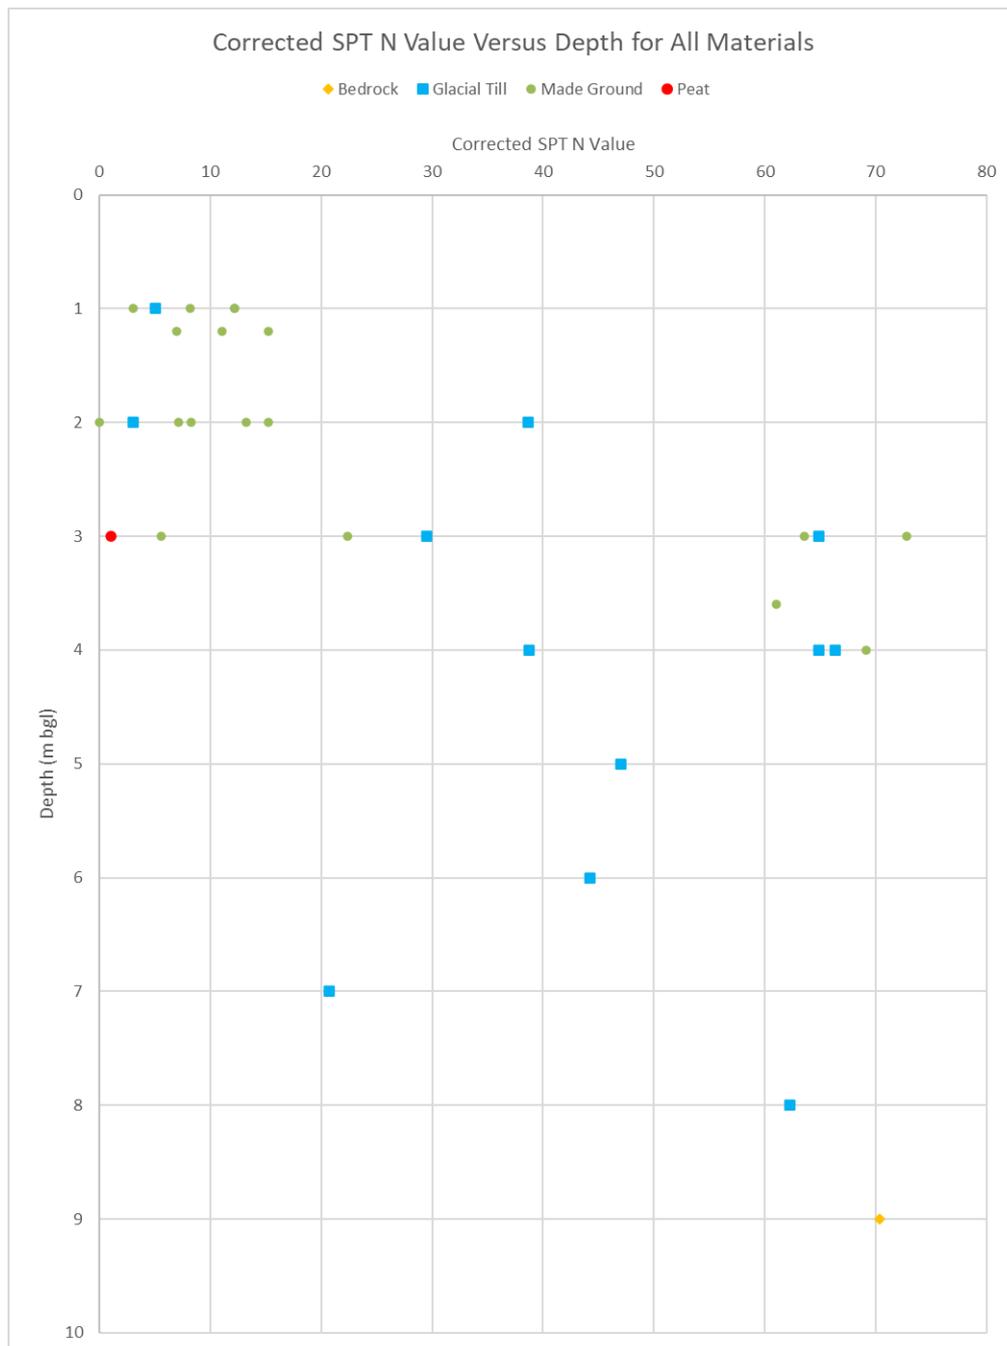
Graph 1: Plot of Corrected SPT N-Values Versus Depth

In-situ SPTs were undertaken to assist with the interpretation of strata encountered. The SPT N-values have been corrected based on the Energy Ratio of 61% for the SPT hammer on the window sampling rig and 85% on the cable percussive rig. The SPT Hammer Energy Test Reports, undertaken in accordance with BS EN ISO 22476-3:2005 are included in **Appendix A**. The results of corrected N-values versus depth are plotted in the graph below:

While the undrained shear strength estimated from SPT N values for the Glacial Till below approximately 5m was generally in excess of 100kPa, the results of the laboratory analysis indicated that there were weaker zones present. This could either be due to presence of softer zones or layers with a reduced proportion of fines (clay and silt). Given this variability it is recommended that piles end bear within the more consistent bedrock.

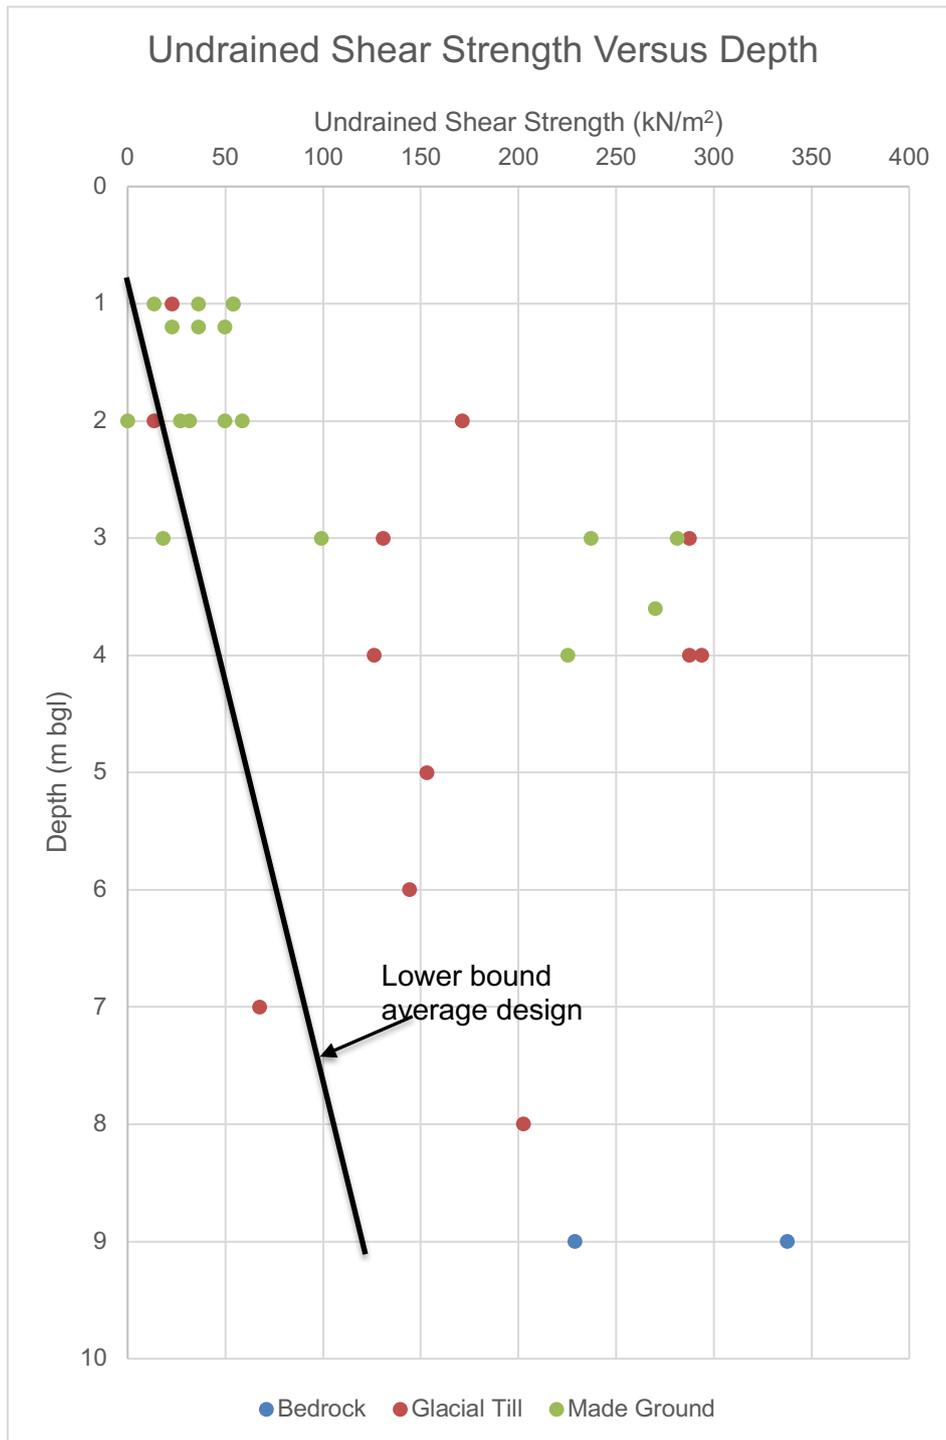
Graph 2: Plot of Mass Shear Strength Versus Depth

While the Plasticity Indices determined in the laboratory ranged from between 17 and 20%, the majority of these were samples of the near surface made ground. For this reason a slightly conservative plasticity index of 25% been assumed which equates to an f_1 factor of 4.5.
