## Summary Technical Due Diligence Report

Severn Bridge Social Club, Bulwark Road, Chepstow,  
NP16 5JX

April 2021

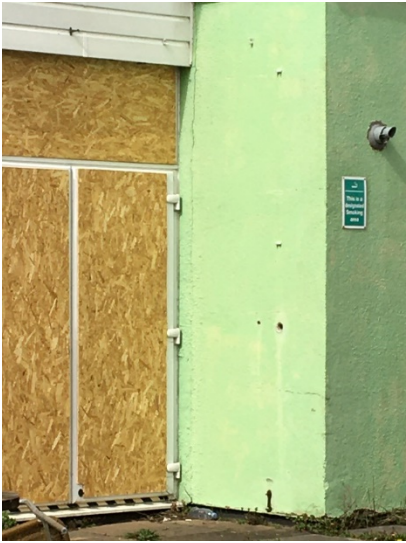
3.7 Cracking was noted to the external front and side wall of the skittles room with a previous repair noted. Further investigations into the cause of these cracks should be undertaken by a structural engineer. A provisional sum has been allowed for within appendix A.	1

Photo No	Photograph Description	Photograph
13.	Crack to wall, mirrored internally.

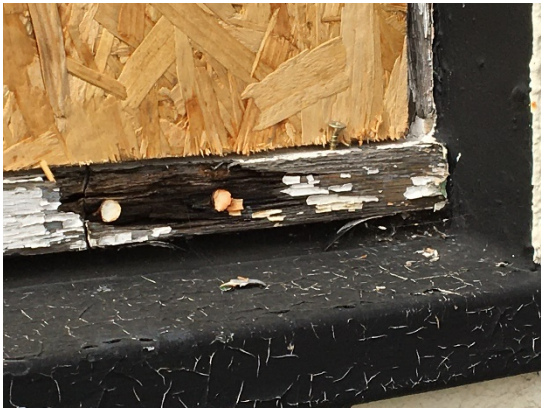
3.11	Timber windows to the south east elevation are suffering from wet rot decay. These windows should be replaced with modern uPVC alternatives to match the existing.	<b>1</b>

14.	Rot to timber casement windows to south east elevation.

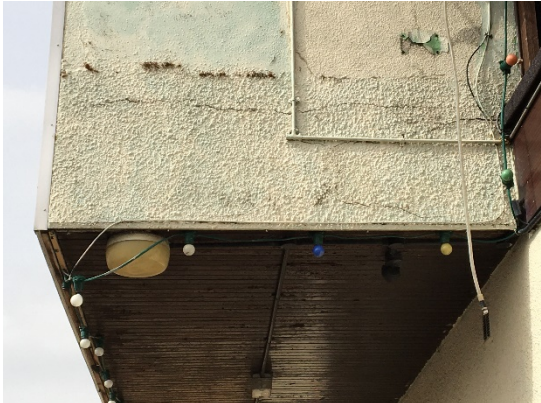
3.8 Horizontal, tapered cracking was noted to either side of the cantilevered section of the steward's accommodation which forms the canopy directly above the front entrance. This would suggest that the structural steelwork has deflected, and the first floor has settled at a lower level. Vertical cracking was also noted to the internal wall of the small corner room to the right of the stage which is mirrored externally. Further investigations into the cause of these cracks should be undertaken by a structural engineer. A provisional sum has been allowed for within appendix A.	1

15.	Horizontal cracking to entrance canopy.

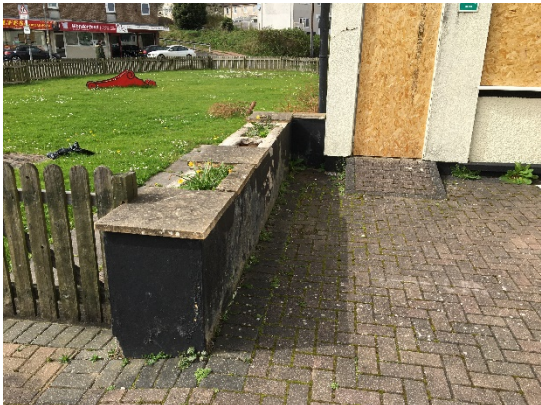
Photo No	Photograph Description	Photograph
16.	Missing paving slabs and blown plaster to low level wall to front entrance.

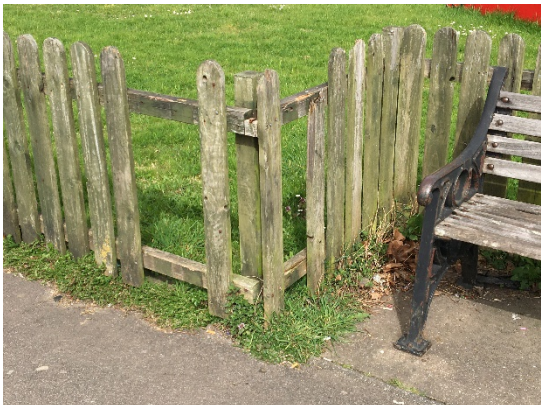
17.	Damage to timber fencing surrounding lawned area.

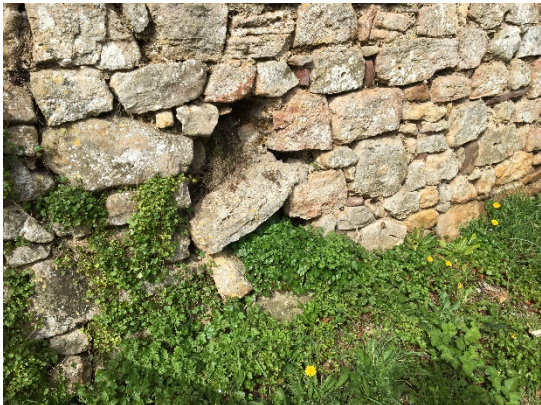
3.15	The stone rubble wall to the north, west elevation has large scale vegetation growth and the mortar joints have failed. Many of the stones have become dislodged leaving the wall in a poor condition. Works should be undertaken in the short term to remove the vegetation and ensure the integrity of the wall.	<b>2</b>

18.	Stone rubble wall to boundary.

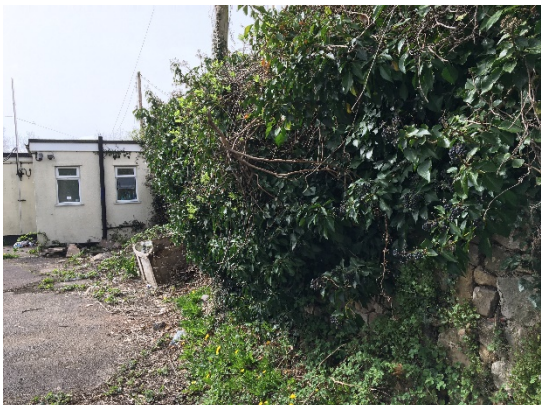
19.	Vegetation growth to stone wall.

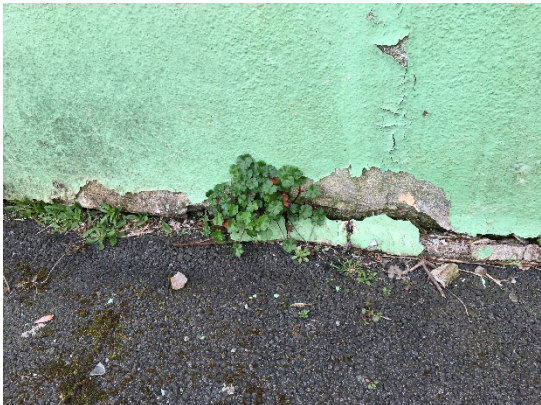
3.14	Rough cast render to the external face of the building is damaged/blown and paint is flaking to numerous locations. Works should be undertaken remove blown sections of render and reinstate before undertaking full redecoration.	<b>2</b>

Photo No	Photograph Description	Photograph
20.	Damage to render.

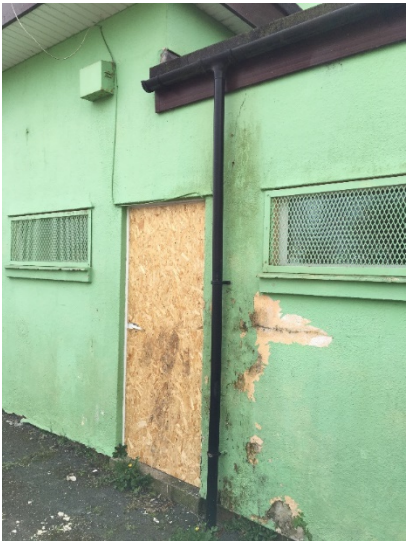
Structure and Fabric	Risk Rating
3.4 Rainwater goods have suffered from a lack of maintenance and are blocked allowing water to run down the face of the building. Damage to gutters to the north west of the hall and disconnected downpipe to first floor accommodation was noted. Rainwater goods should be unblocked and repaired in the short term to prevent further damage to the building fabric.	1

21.	Rainwater goods overflowing and damaging render.

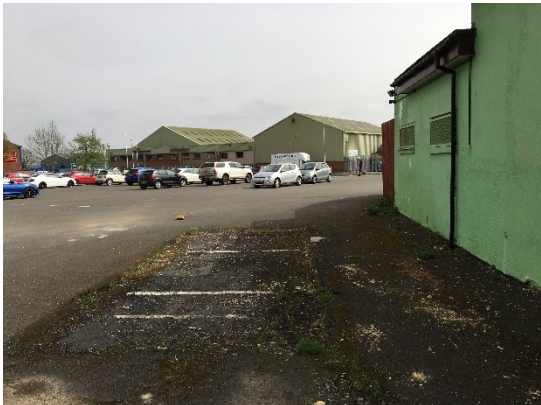
3.18	The tarmacadam to the carpark is pitted and worn to isolated locations. Patch repairs should be undertaken in the medium term to ensure term to avoid further damage to the surface and damage to vehicles.	2

Photo No	Photograph Description	Photograph
23.	Damage to macadam hard standing.

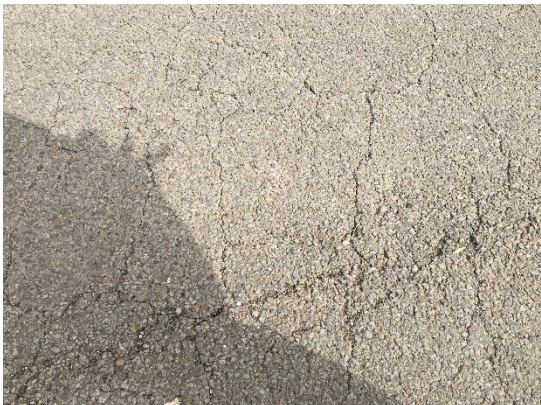
24.	Crazing to macadam hard standing.

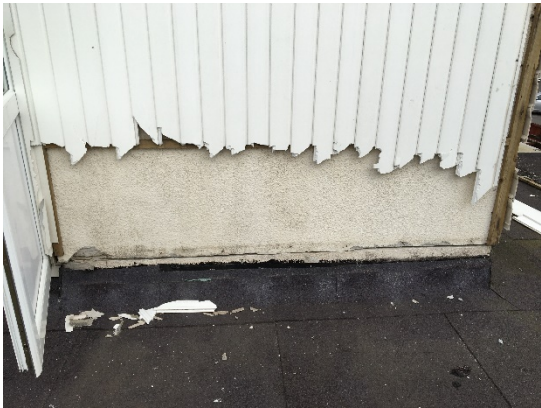
3.6 The external uPVC wall cladding and soffit to the main hall has been damaged and roughly stripped along the south and south east elevation of the flat roof. The cladding is cracked and worn and overall, in a poor condition It is recommended that a wholesale replacement of all wall cladding should be undertaken.	1

Photo No	Photograph Description	Photograph
27.	Damaged cladding.

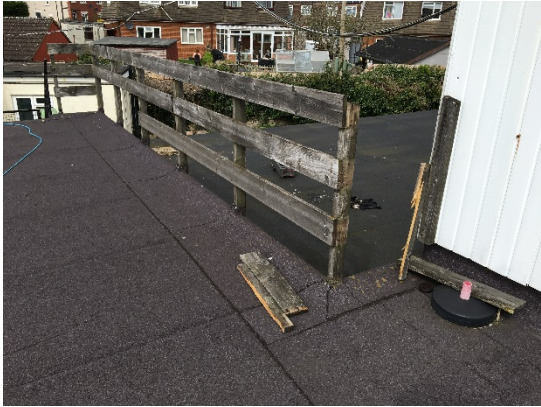
29.	Damage to timber fencing on fire exit rout.

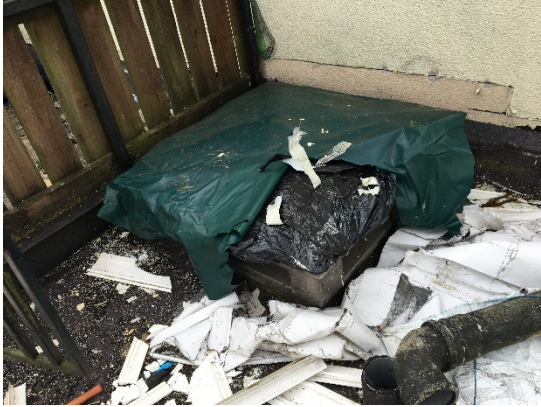
3.10	Glazing is smashed to several windows to the south west elevation at ground floor and first floor level. There are also a number of dome roof lights which are either smashed or damaged allowing water to enter the building. The windows are currently boarded or covered and as such are not causing any further damage to the building fabric. However, glazing should be replaced in the short term if the building is to be re-let.	<b>1</b>

30.	Damage to sky light.

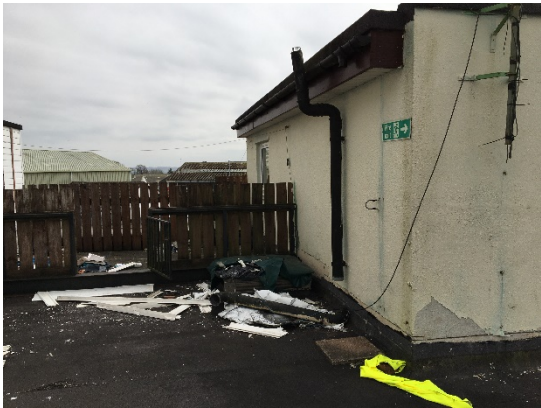
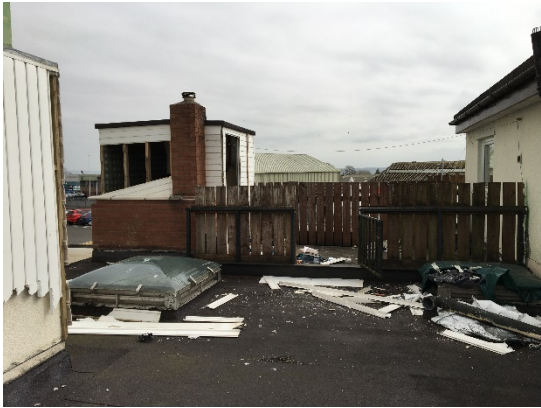
<p>3.3 Extensive quantities of debris and waste material have been left on the roof. These should be removed in the short term.</p>	<p>①</p>

Photo No	Photograph Description	Photograph
31.	Debris to roof.
