PHASE 1 SITE INVESTIGATION & PRELIMINARY RISK ASSESSMENT

Lidl Great Britain Ltd

Former Severn Bridge Club, Chepstow

799.01.02
July 2021

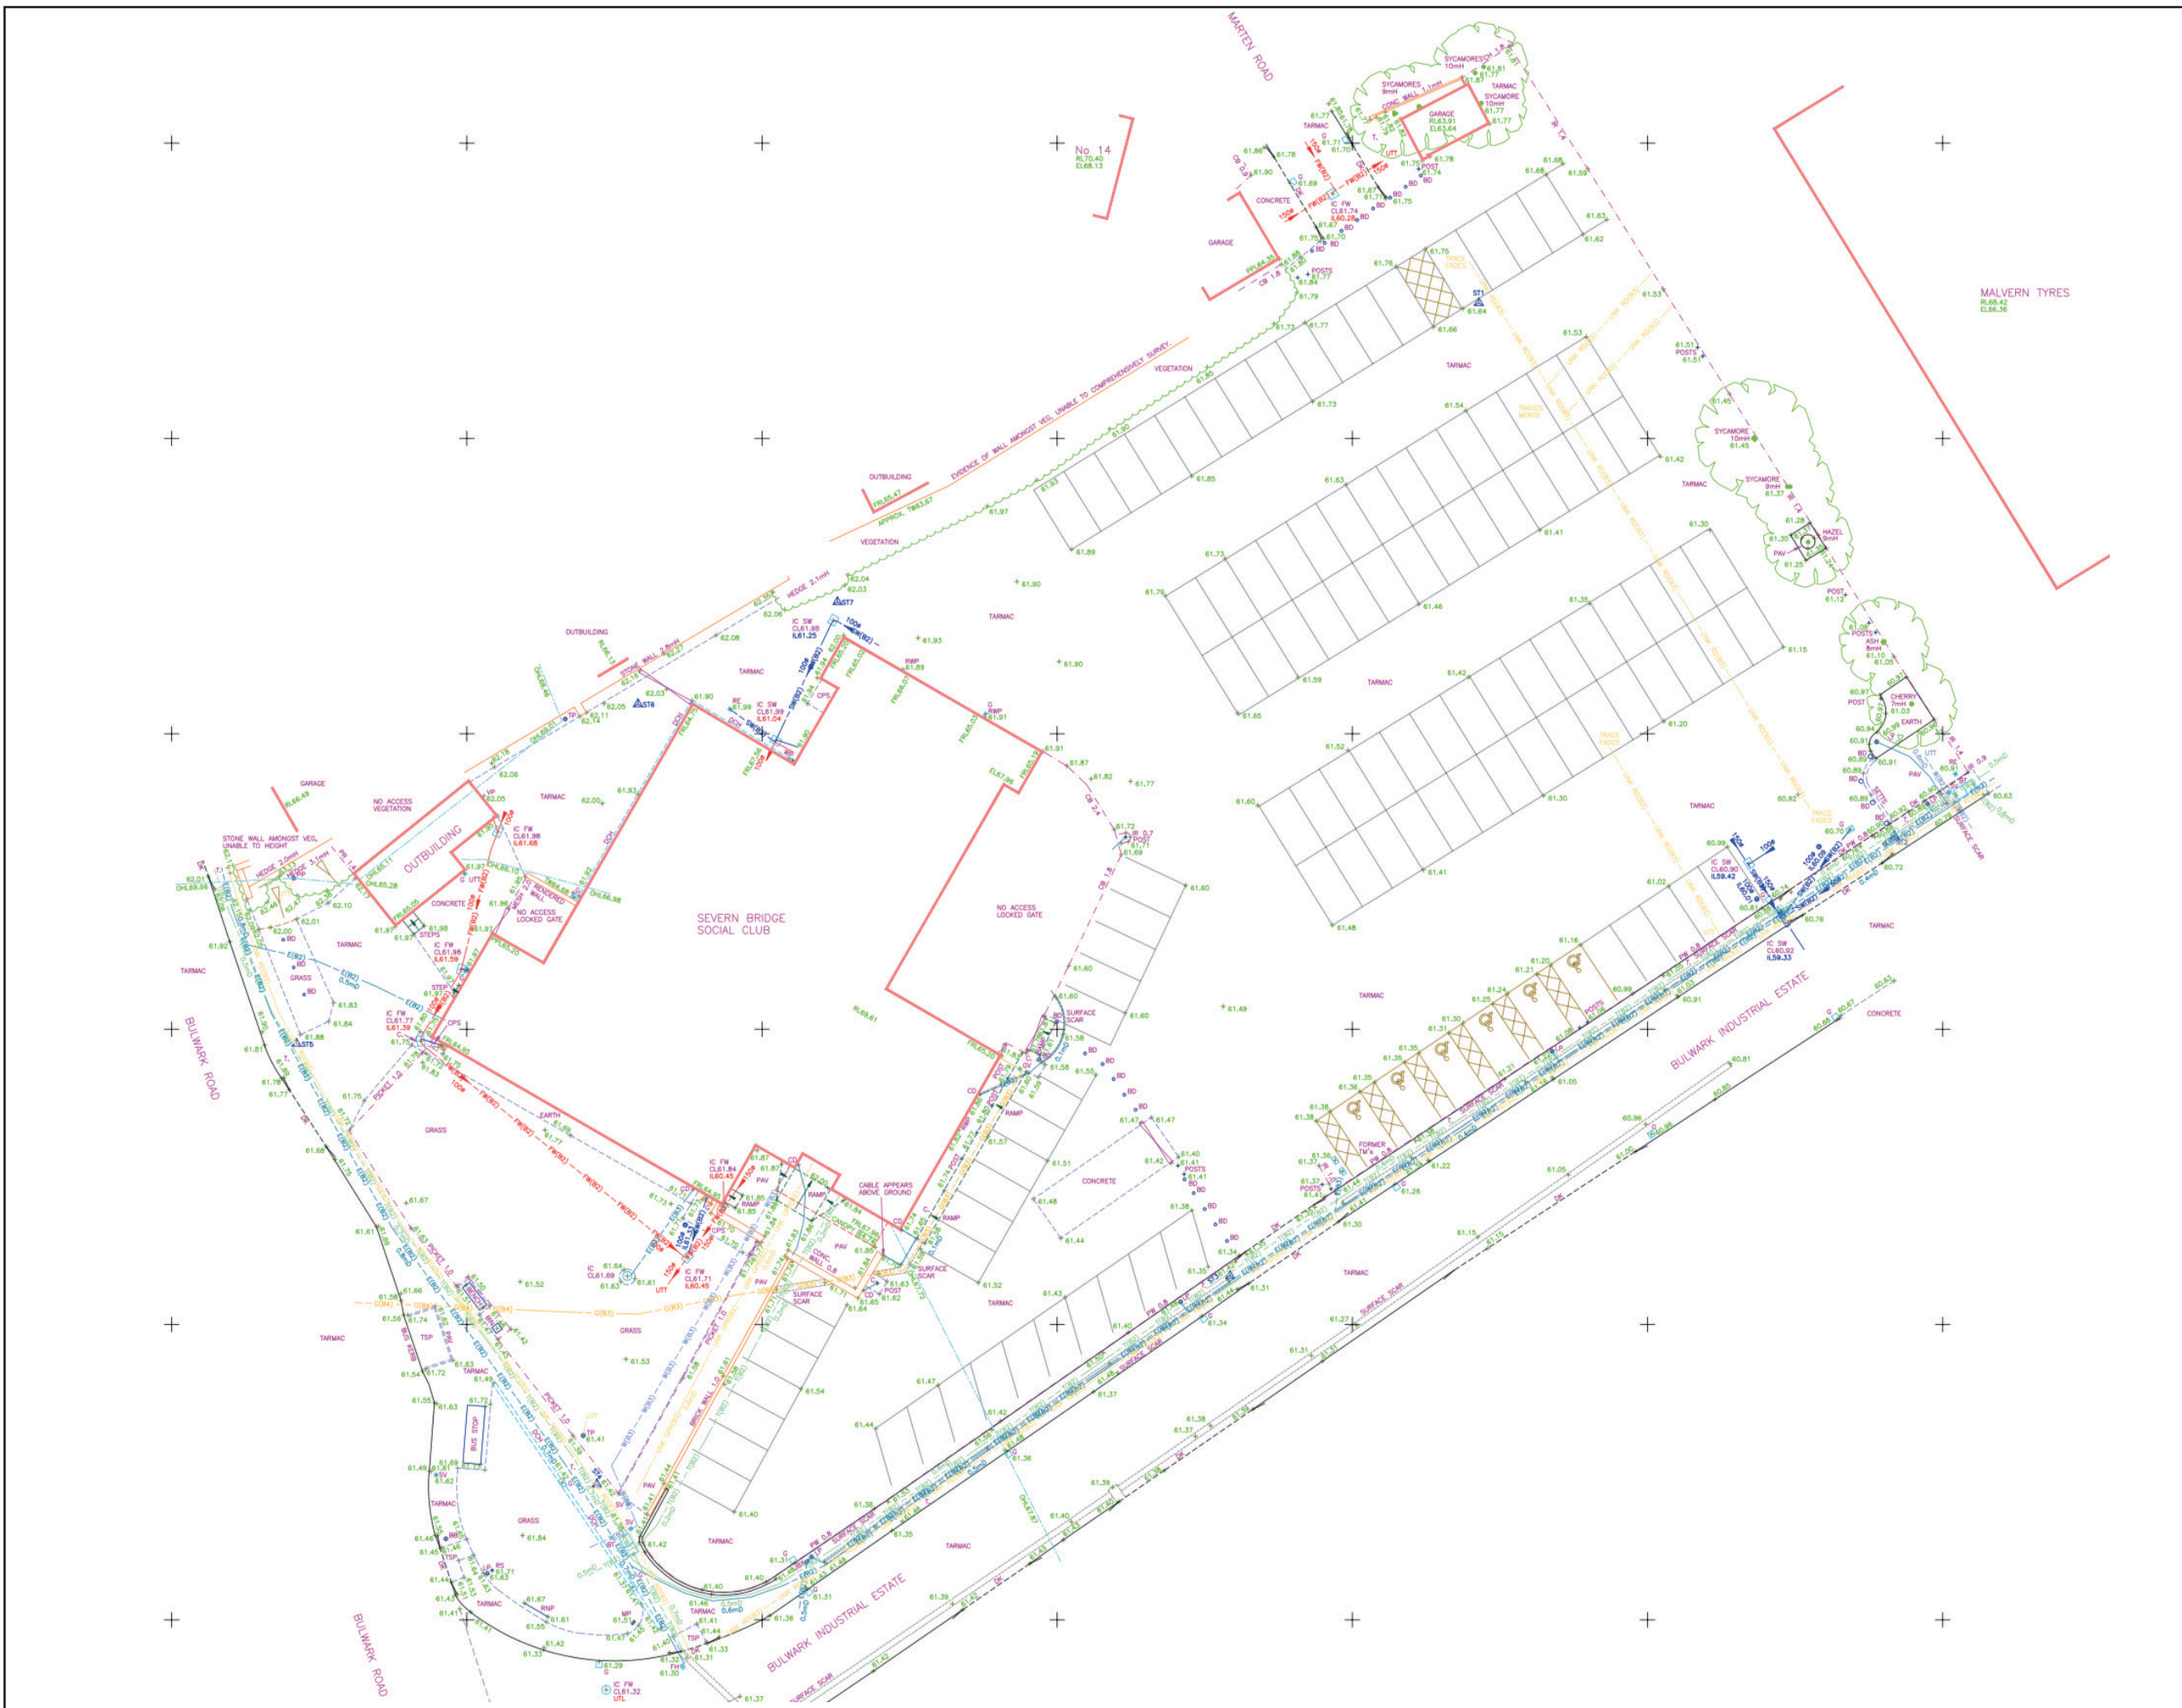
Figure 2 Existing Site Layout

The site is currently occupied by the former Severn Bridge Club building and surrounding car park, and the adjacent Malvern Tyres, as indicated in **Figure 2**. The southern and south western site boundaries are delineated by wire mesh fencing, with part of the western boundary comprising wooden fencing. Hedgerows delineate part of the northern boundary. Metal fencing currently separates the Severn Bridge Club and Malvern Tyres.

Note:
 Existing topographic and layout drawing reproduced from EDI Survey Ltd's Topographic & Services Survey, drawing No. 19190/T/01-01, issued in November 2020

The site is currently occupied by the former Severn Bridge Club building and surrounding car park, and the adjacent Malvern Tyres, as indicated in **Figure 2**. The southern and south western site boundaries are delineated by wire mesh fencing, with part of the western boundary comprising wooden fencing. Hedgerows delineate part of the northern boundary. Metal fencing currently separates the Severn Bridge Club and Malvern Tyres.
