Lidl Great Britain Ltd

DRAINAGE STRATEGY REPORT

Blackpill, Swansea

OUR REF. NO. 0327-WSP-XX-XX-C-RP-0510

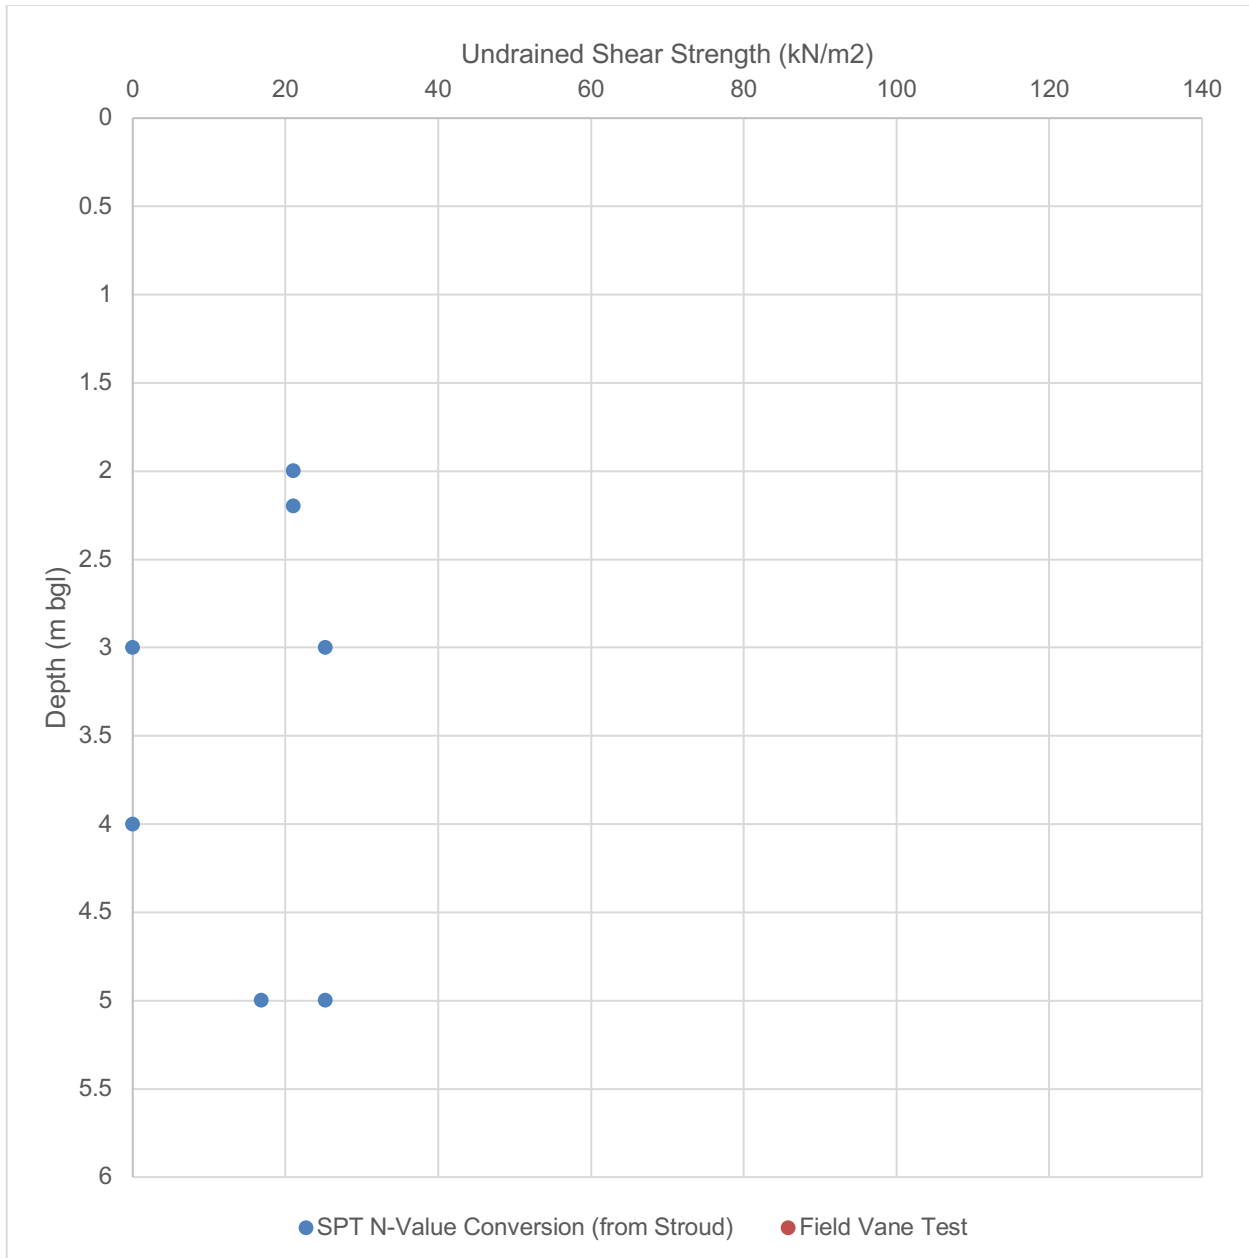
Graph 2: Plot of Mass Shear Strength Versus Depth

Undrained shear strengths have been estimated from SPT N values using the relationship developed by Stroud (*The standard penetration test in incentive clays and soft rocks*) and summarised in Tomlinson where:

Where f_1 is based on the plasticity index.

A Plasticity Index of 32% has been assumed (based on geotechnical laboratory testing) which equates to an f_1 factor of 4.2.
