Existing Photos

Opportunities & Constraints

Heritage Statement

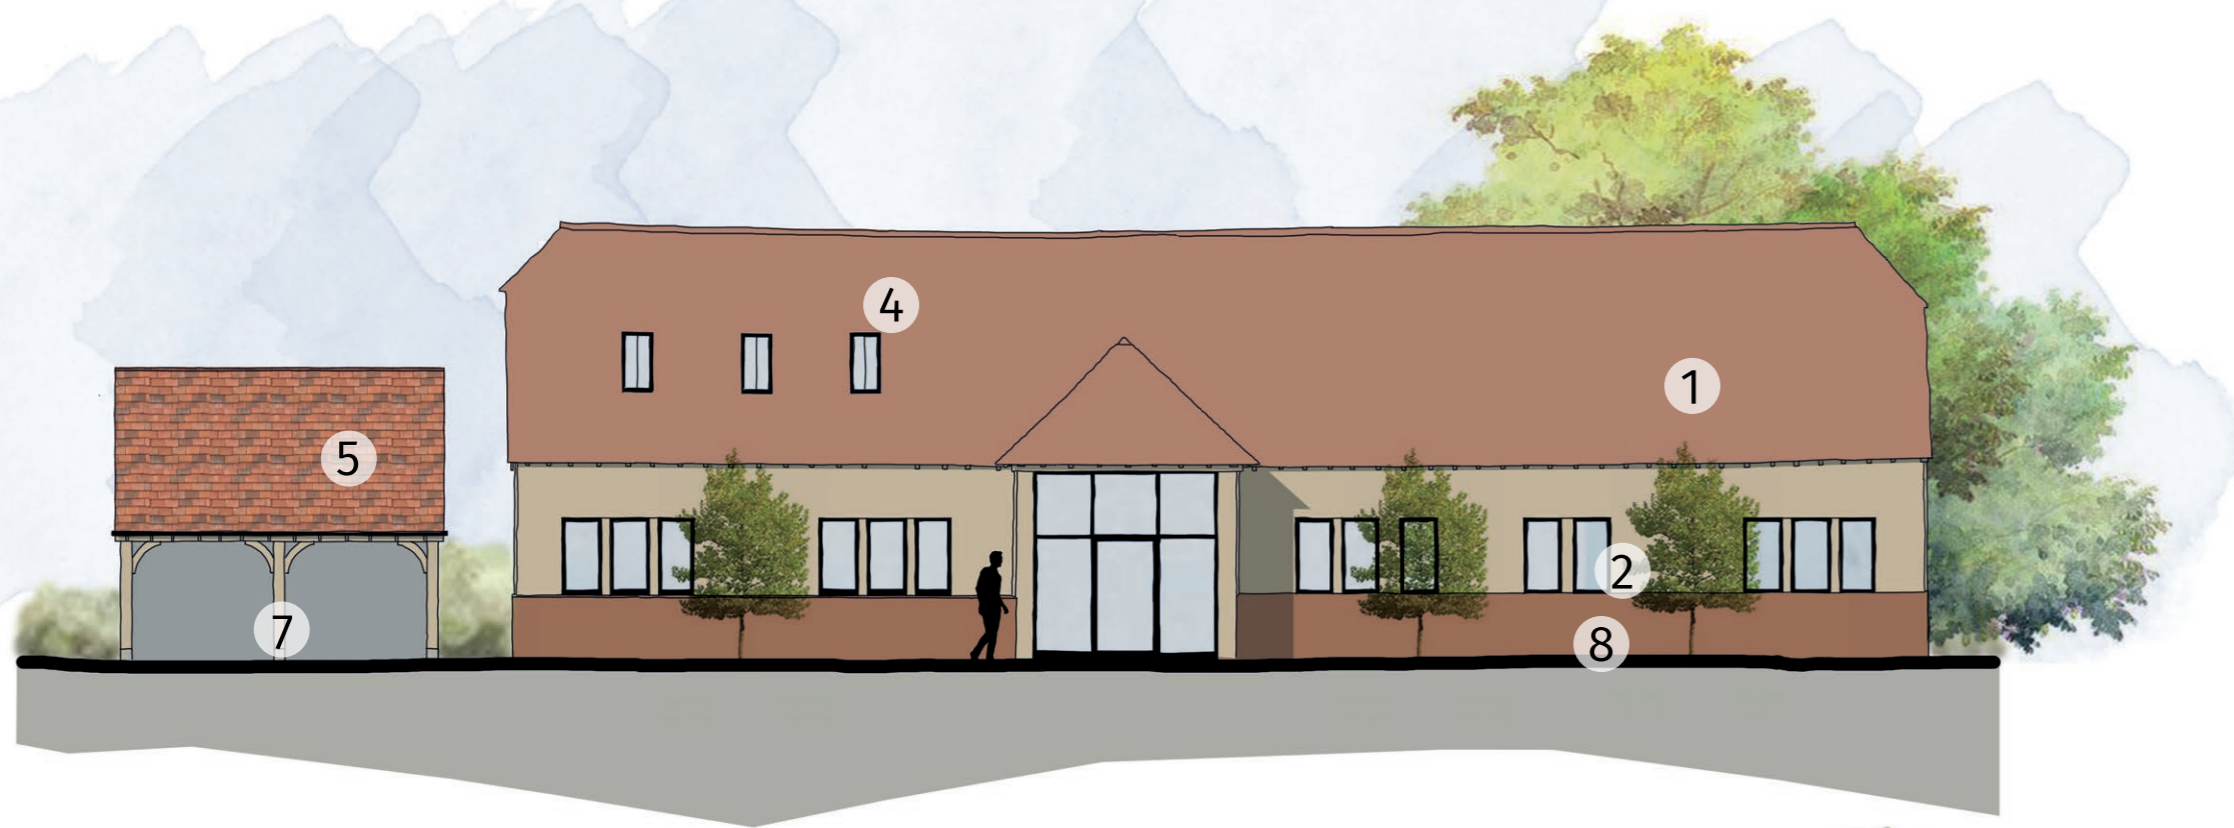
Above: Proposed Elevation 1 - Not to scale

Material Key

- 1) Existing plain clay tiles
- 2) New painted timber windows
- 3) New horizontal natural timber cladding to match existing
- 4) New conservation roof lights
- 5) New clay tiles to match existing
- 6) Existing horizontal natural timber cladding
- 7) New oak posts and braces
- 8) Existing red brick
